Site-Safe Products of Florida, LLC is a one-of-a-kind "Certified Trinity TRACC™ Family Crash Cushion Repair Center" specializing in turn-key maintenance, repairs, sales, and installations throughout the state of Florida.

T rinity
R edirective
A ttenuating
C rash
C ushman

TRACC Repair

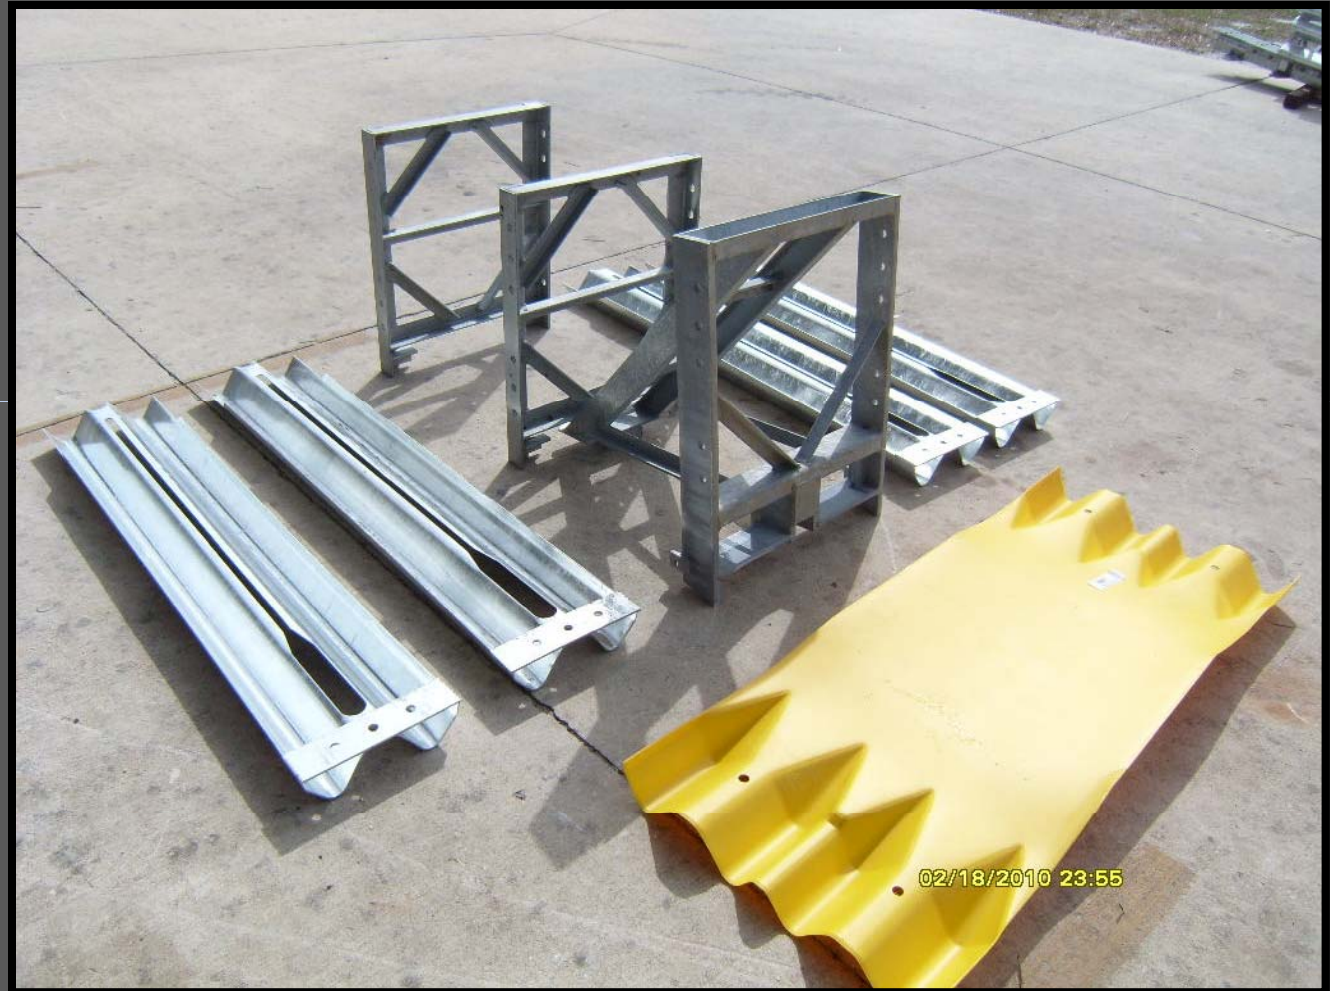
BASIC *TRACC* COMPONENTS INCLUDE

- NOSEPIECE
- SLED
- FRAMES
- FENDER PANELS

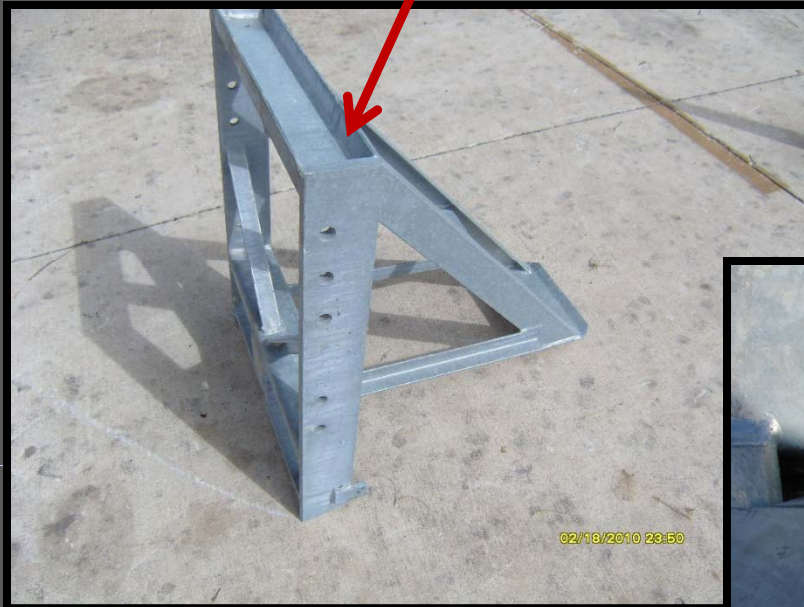
TRACC SLED IS EQUIPED WITH CUTTER BARS

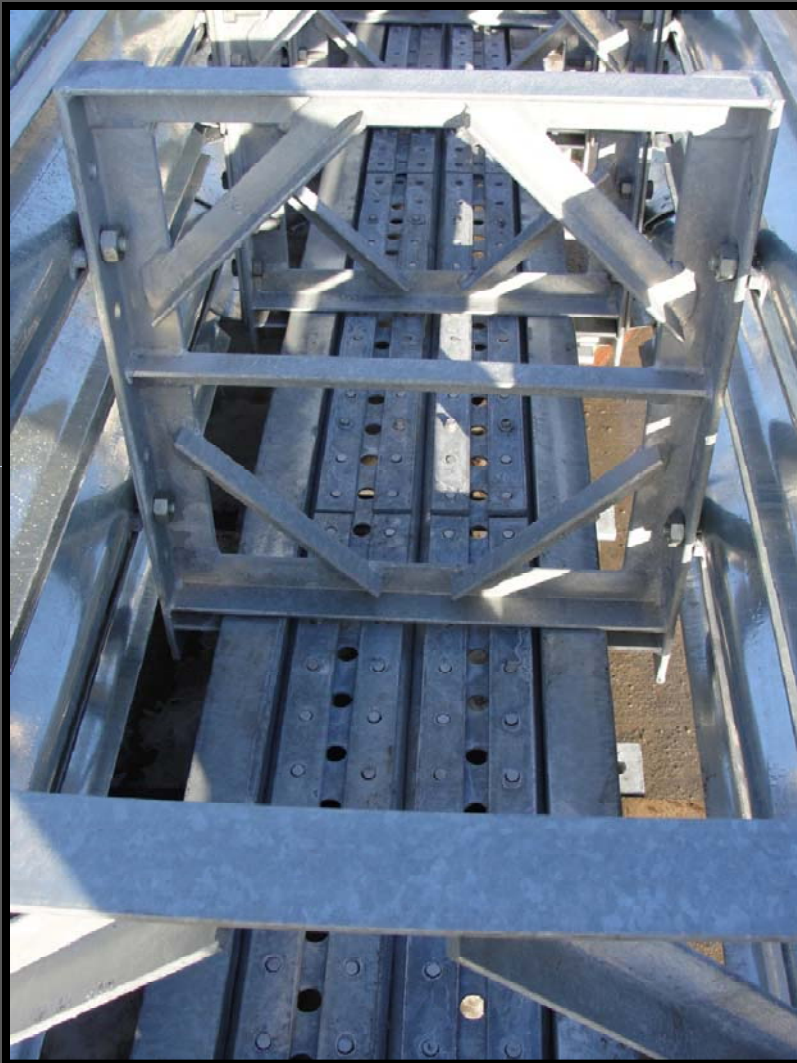
AS *TRACC* SLED SLIDES; CUTTER BARS SLICE THRU RIP PLATES

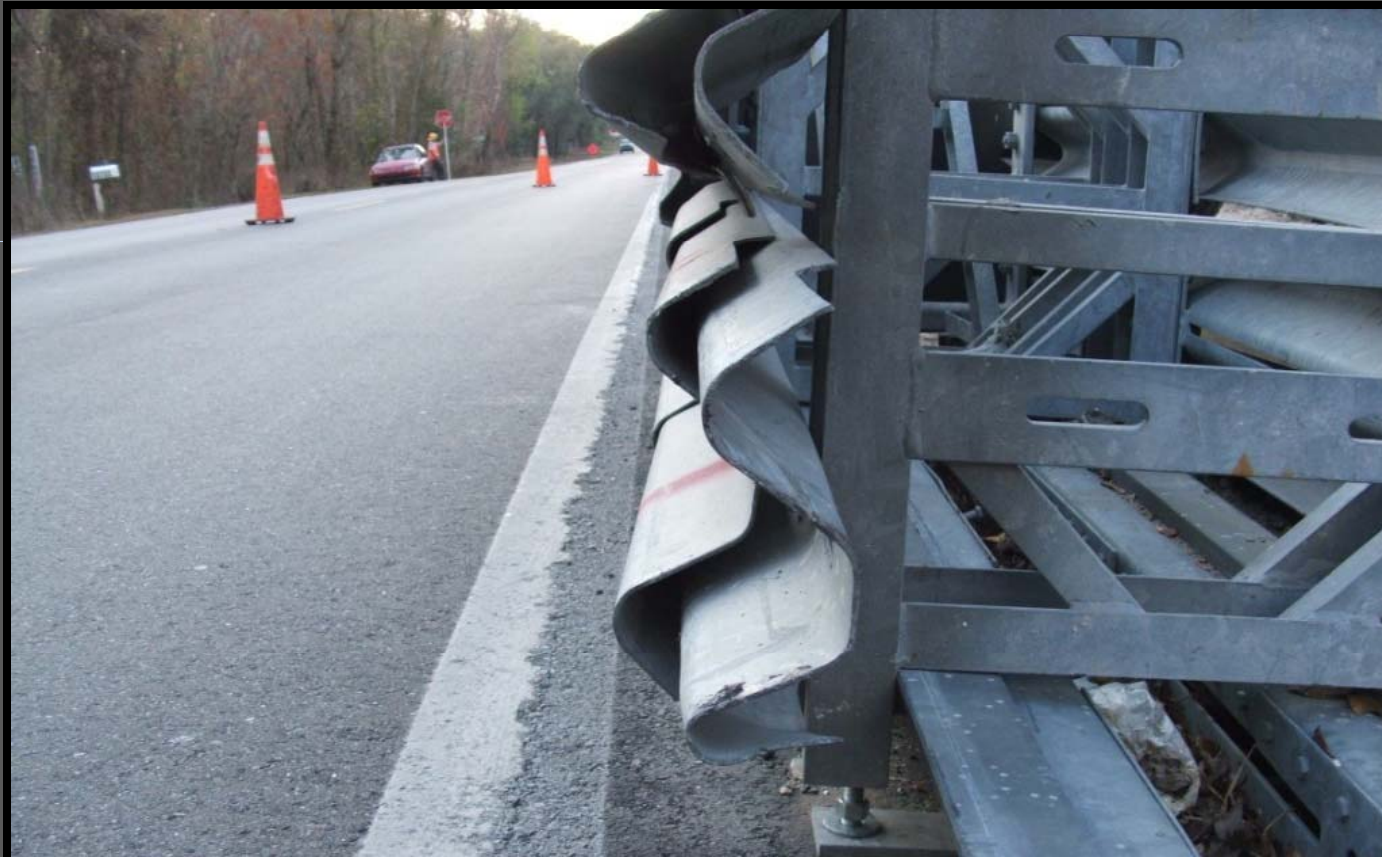
- PROPER MOT
- THOROUGH UNIT INSPECTION IS CRUCIAL, INSPECT FOR CRACKED WELDS, BENT PARTS, BROKEN PARTS

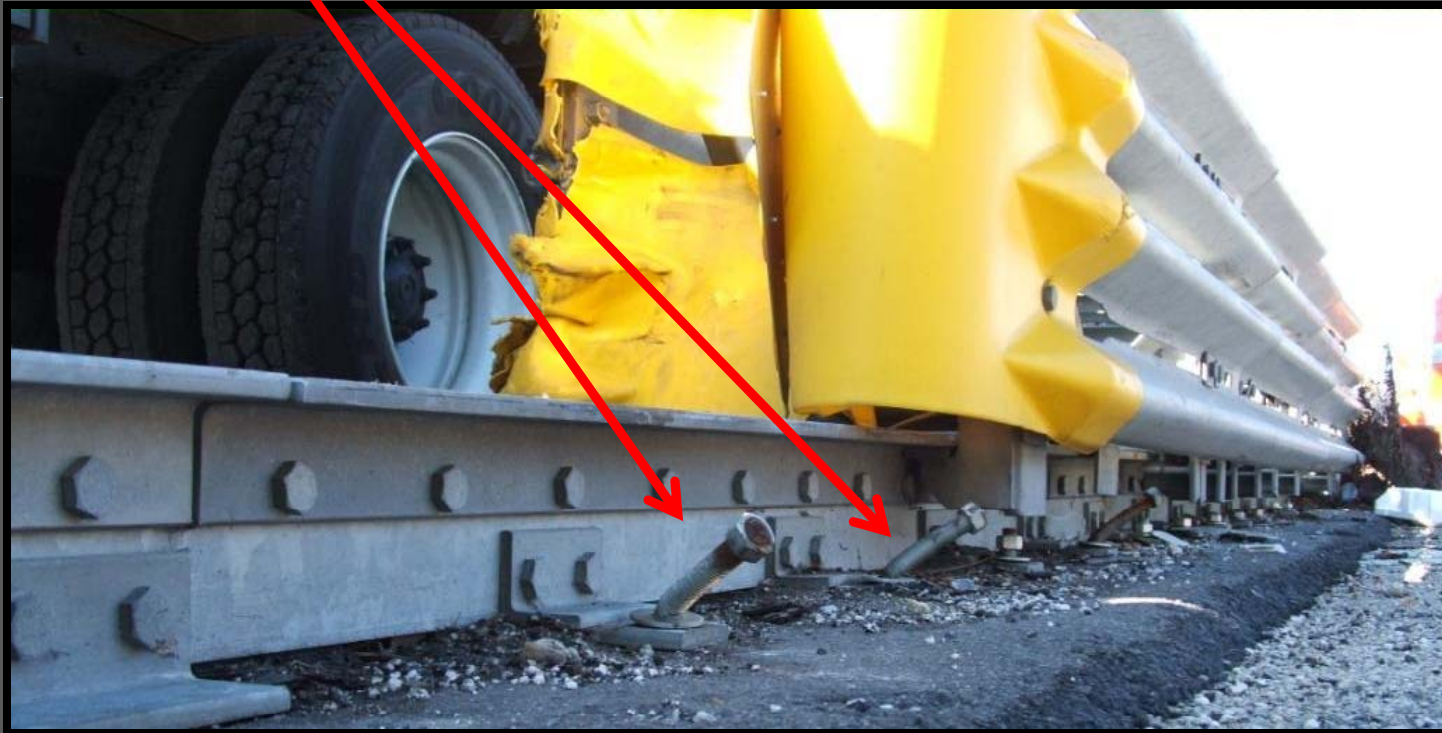
TRACC Repair

- NUISANCE IMPACTS (Less than 4 ½ feet) ONLY REQUIRE YOU PULL SLED TO FRONT OF UNIT
- INSPECT UNIT ANCHOR RODS

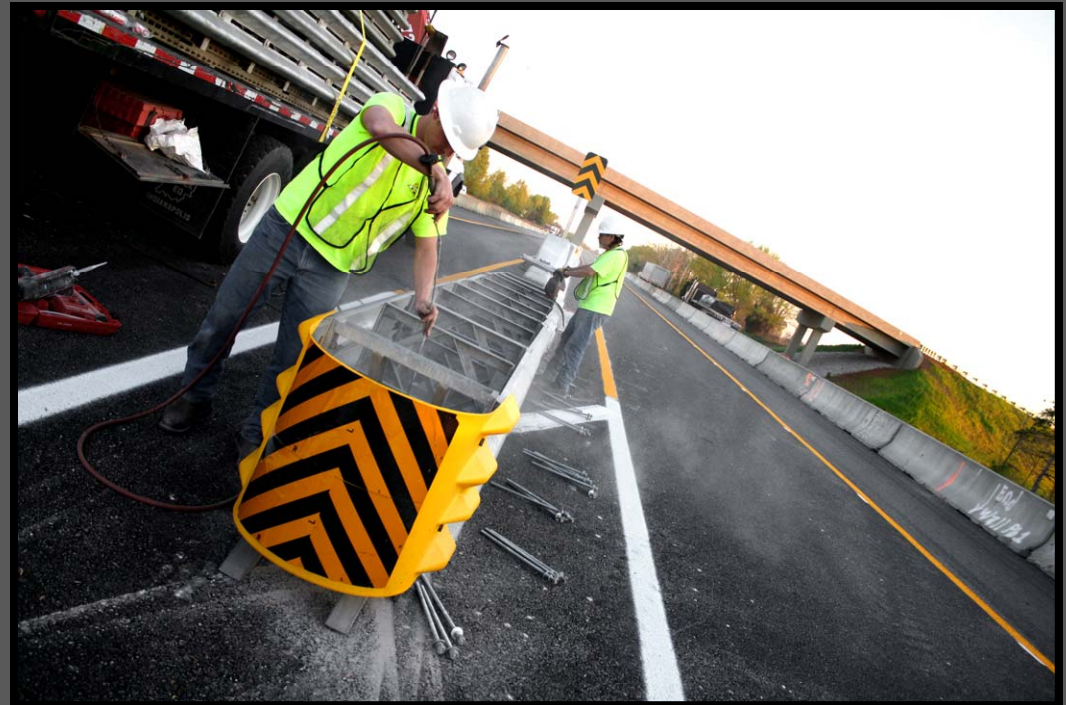
INSTALL, Proper installation is crucial for minimizing damage to your attenuator.

Common Install Pitfalls

- Shallow drilling
- Failure to drill all holes
- Failure to aerate holes
- Insufficient epoxy/ wrong epoxy
- Checklist for employees
- Supporting pictures
